Testing of Wood Finishes for Durability - June 2004

Bed Wood Finish Update - September 15, 2004

Bed Wood Finish Update - December 20, 2004

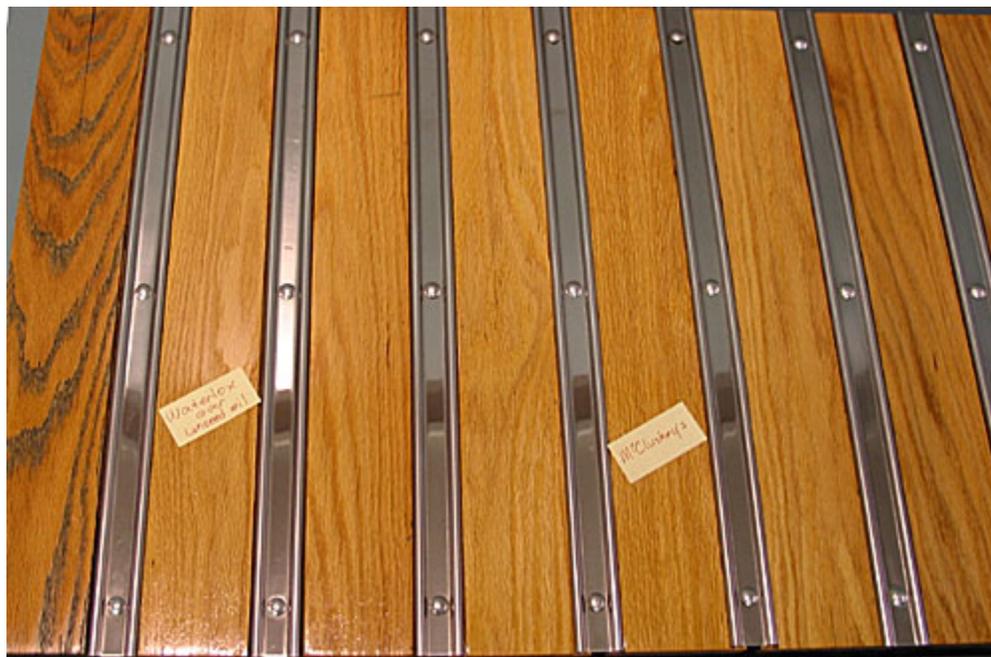
The test has been in place continuously for about 7 months. During this time the weather ranged from over 100 degrees to the low 20's, and we had one of the wettest summers ever. The unusual weather took its toll on the sample finishes.

At this time, all the finishes have failed to at least some degree. We will conduct another test beginning about February 2005, using the coating systems that performed the best and adding other promising finish systems. Following are some notes regarding the performance of each coating.

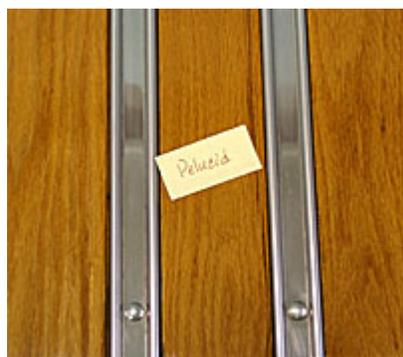
Pelucid This coating seemed to be the most durable of the coatings tested. It is a one part "moisture cure" urethane made by POR 15. It developed a very small area of separation of the coatings, and also a small hairline crack in the finish which allowed moisture to penetrate to the wood substrate. Both failures occurred near the end of the test period. Another concern with the Pelucid is that the boards coated with Pelucid darkened noticeably during the test period. Pelucid goes on practically water clear so the boards were initially very light colored. During the course of the test, the boards coated with Pelucid darkened more than the other coatings. This may have been caused by the sunlight and the coating lacking sufficient UV protection to prevent discoloring. We will include Pelucid in the next test series.

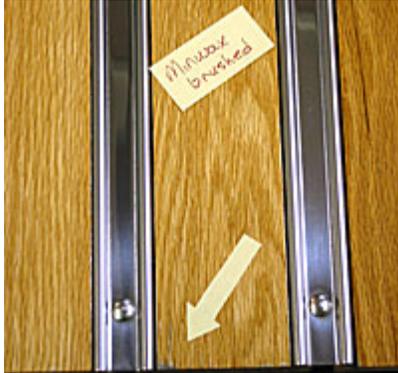
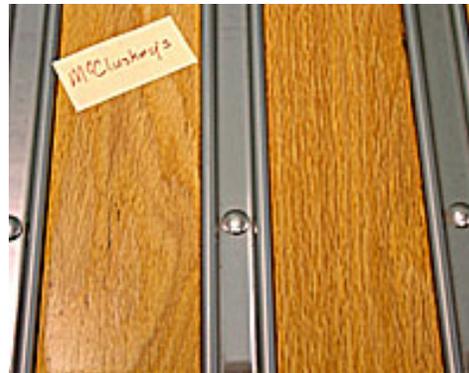
McCluskey's Man-O-War and Minwax Helmsman Both of these had similar characteristics and both performed about the same. It didn't make much difference whether they were sprayed or brushed. They developed a few small cracks in the coating allowing moisture to penetrate to the wood. This of course caused the typical gray-black stain along the crack which is very difficult to remove. The minwax samples were pulled from the test and sanded and recoated. The intent was to place them back into the test and continue. However, since all the other samples failed, we decided to stop the current test. Two of the boards shown have been recoated. The sanded and recoated Minwax and McCluskey's samples shown from this first test will also be included in the next round of testing which will begin about the end of February.

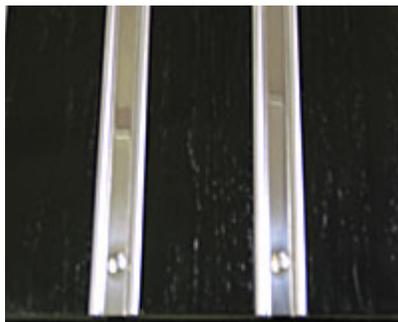
Behr black exterior latex enamel. This paint also developed small hairline cracks which indicates coating failure. The gloss seemed to be still good and no coating separation or peeling occurred. We will include a paint coating in the next tests. The specific brand and type have not been selected.

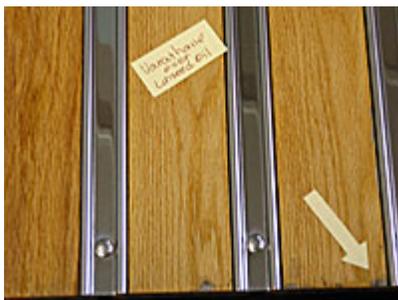
Varathane exterior gloss urethane. The samples which were sealed with linseed oil first lasted much better than the samples which were applied directly over bare wood. This product was not as durable as Minwax or McCluskey's in our tests. We have decided not to continue testing the Varathane product.

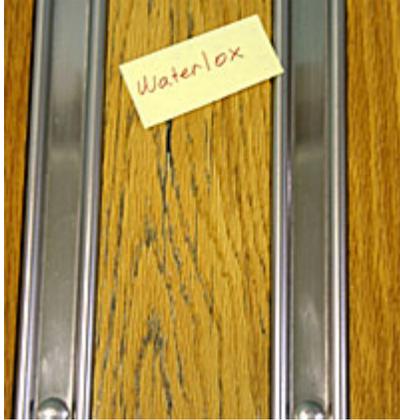
Waterlox The Waterlox used with the Waterlox sealer failed fairly early in the testing. It was not repaired. The Waterlox applied over dried linseed oil sealer lasted much better. It appeared to have a few minor cracks in the coating by the end of the test, but the linseed oil protected the underlying wood from extensive damage. These will be sanded and recoated for further testing.

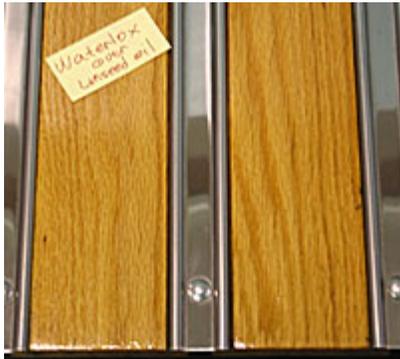
Using Linseed Oil to seal the wood before coating provided some benefit in preventing water damage, even when the coating film had small areas of failure. We hope to do more research here and find a way to evaluate this method of sealing the boards before coating.

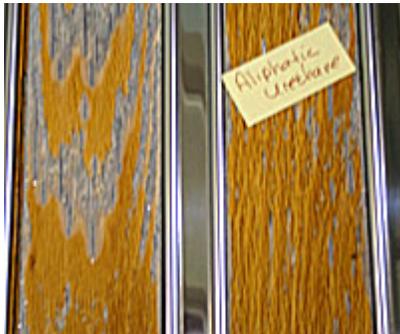
Aliphatic Urethane failed almost immediately. The manufacturer has suggested an alternative coating and application procedure. These will be included in the next coating tests.
