## Testing of Wood Finishes for Durability - June 2004

## ***Bed Wood Finish Update - September 15, 2004***

## ***Bed Wood Finish Update - December 20, 2004***

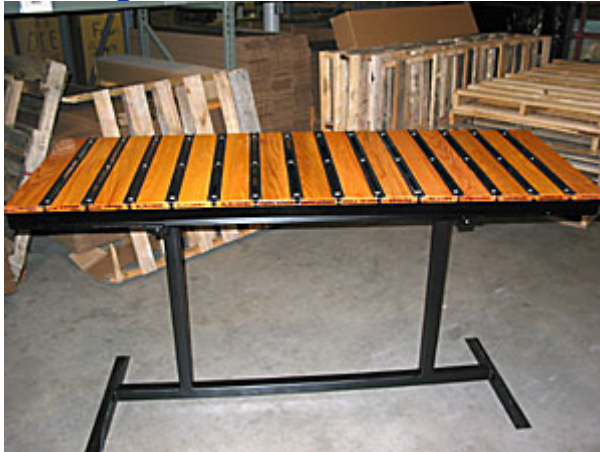
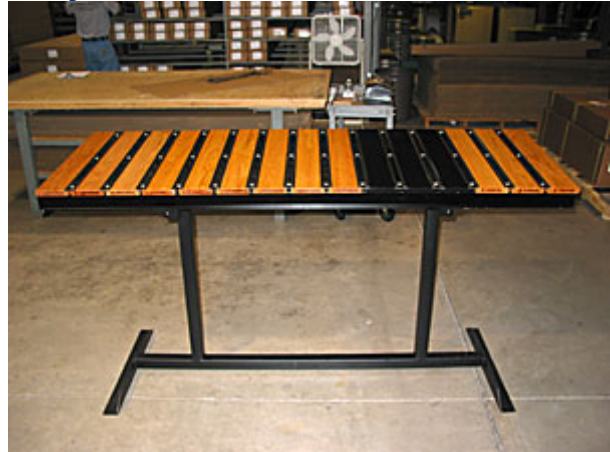
Our testing procedure is as follows. Ten different bed wood finishing methods are being evaluated, and three oak boards have been finished by each method for a total of 30 boards being tested. The finishing products were applied to all surfaces of the boards according to the instructions provided on the can. All were allowed to cure at least 30 days before being placed in the test fixtures. The boards are attached to cross sills by our type 430 stainless bed strips using unpolished stainless bolts. This test procedure simulates the conditions of a typical bed wood floor in a truck that is used regularly and sees plenty of outdoor use.

These boards have been mounted on a display stand and are positioned outdoors near the northwest side of our manufacturing building. This will expose the boards to the extremes that Oklahoma weather has to offer - from 110-degree summer sun to rain and hail to driving snow and freezing rain. We will regularly inspect the wood for signs of failure in the finishing system and provide monthly progress reports. We will perform monthly washing of the wood and strips and will wax them about every six months, typical of the care you would give your own bed wood. Watch the website bed finish test page, which will be updated regularly.

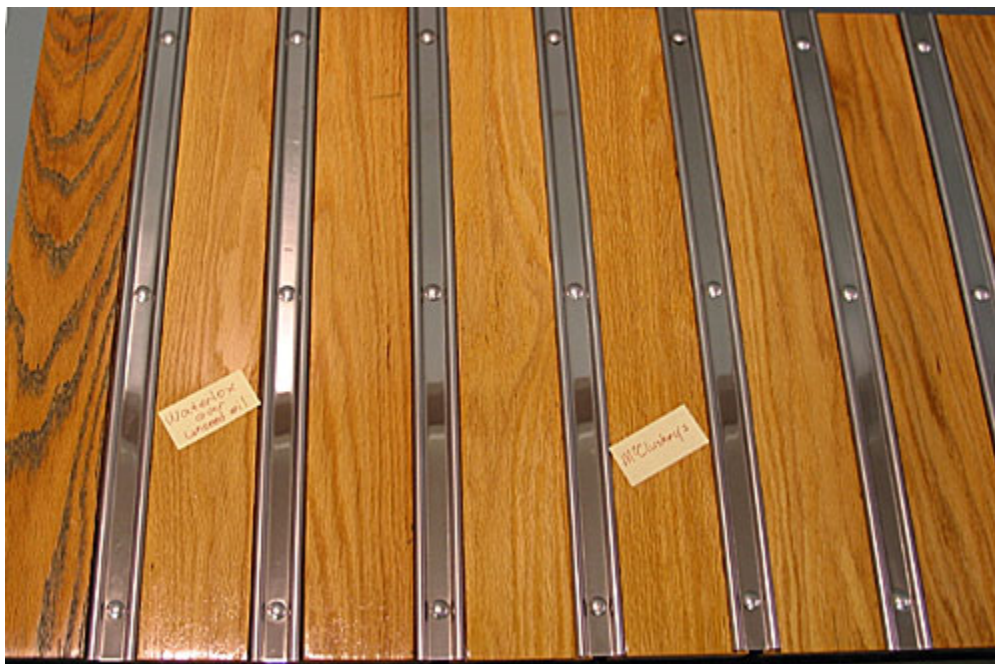
The test has been in place continuously for about 7 months. During this time the weather ranged from over 100 degrees to the low 20's, and we had one of the wettest summers ever. The unusual weather took its toll on the sample finishes.

At this time, all the finishes have failed to at least some degree. We will conduct another test beginning about February 2005, using the coating systems that performed the best and adding other promising finish systems. Following are some notes regarding the performance of each coating.

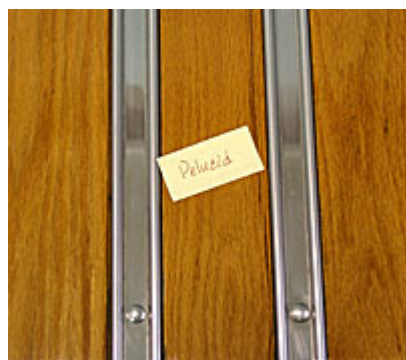
Pelucid This coating seemed to be the most durable of the coatings tested. It is a one part "moisture cure" urethane made by POR 15. It developed a very small area of separation of the coatings, and also a small hairline crack in the finish which allowed moisture to penetrate to the wood substrate. Both failures occurred near the end of the test period. Another concern with the Pelucid is that the boards coated with Pelucid darkened noticeably during the test period. Pelucid goes on practically water clear so the boards were initially very light colored. During the course of the test, the boards coated with Pelucid darkened more than the other coatings. This may have been caused by the sunlight and the coating lacking sufficient UV protection to prevent discoloring. We will include Pelucid in the next test series.

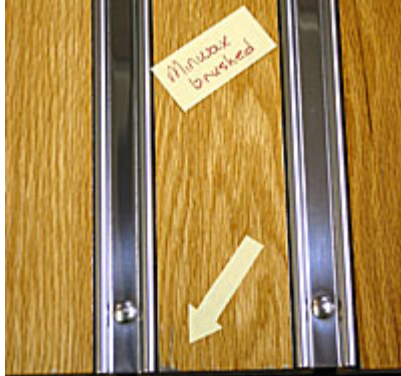
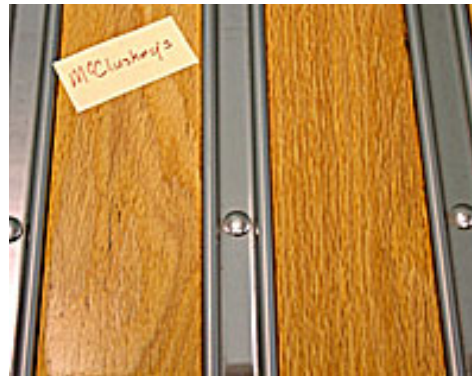
McCluskey's Man-O-War and Minwax Helmsman Both of these had similar characteristics and both performed about the same. It didn't make much difference whether they were sprayed or brushed. They developed a few small cracks in the coating allowing moisture to penetrate to the wood. This of course caused the typical gray-black stain along the crack which is very difficult to remove. The minwax samples were pulled from the test and sanded and recoated. The intent was to place them back into the test and continue. However, since all the other samples failed, we decided to stop the current test. Two of the boards shown have been recoated. The sanded and recoated Minwax and McCluskey's samples shown from this first test will also be included in the next round of testing which will begin about the end of February.

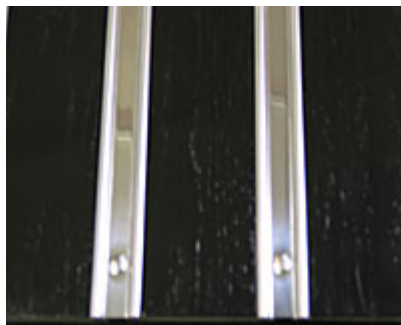
Behr black exterior latex enamel. This paint also developed small hairline cracks which indicates coating failure. The gloss seemed to be still good and no coating separation or peeling occurred. We will include a paint coating in the next tests. The specific brand and type have not been selected.

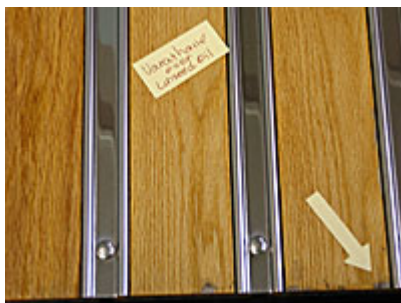
Varathane exterior gloss urethane. The samples which were sealed with linseed oil first lasted much better than the samples which were applied directly over bare wood. This product was not as durable as Minwax or McCluskey's in our tests. We have decided not to continue testing the Varathane product.

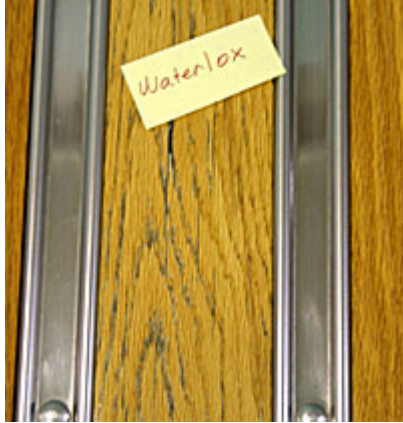
Waterlox The Waterlox used with the Waterlox sealer failed fairly early in the testing. It was not repaired. The Waterlox applied over dried linseed oil sealer lasted much better. It appeared to have a few minor cracks in the coating by the end of the test, but the linseed oil protected the underlying wood from extensive damage. These will be sanded and recoated for further testing.

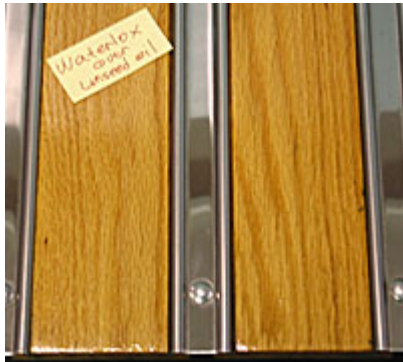
Using Linseed Oil to seal the wood before coating provided some benefit in preventing water damage, even when the coating film had small areas of failure. We hope to do more research here and find a way to evaluate this method of sealing the boards before coating.

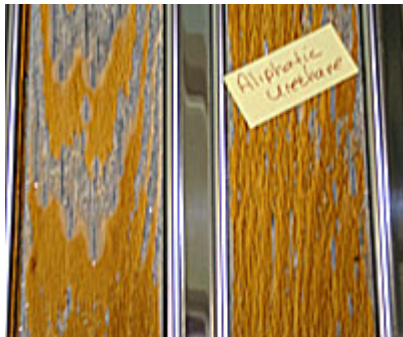
Aliphatic Urethane failed almost immediately. The manufacturer has suggested an alternative coating and application procedure. These will be included in the next coating tests.
