## Installing a 54 GM bed on a 47-53 Frame: Some options, none easy

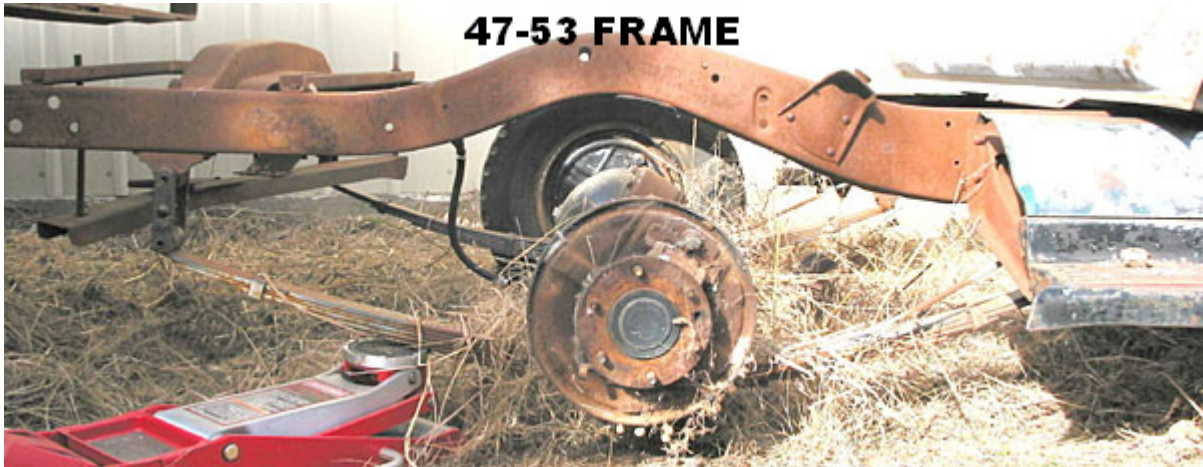
frame. The photos show the two frames and the profile of the 54 frame is noticeably flatter than that of the 47-53 frame.

The main problem with installing a later bed on the 47-53 frame is the earlier frame has a much higher "kick up" or arch over the rear axle area. It is about 4 inches higher than the rest of the frame and the 54 frame "kick up" only rises about 2 inches. A 47-53 bed is installed on wooden blocks under the cross sills that raise the bed about 2-1/8 inches so the bottom of the wood is about 4 inches above the frame, which allows for the 4 inch kick up over the axle. The 54 bed does not use wood blocks under the cross sills so the bottom of the bed wood floor on a 54 truck is about 2-1/8 inches above the

The result of all this math is that when installing the 54 bed on the earlier frame, the bedwood boards rest on the frame kick-up and the cross sills will not rest on the frame as they should. This effectively raises the bed about two inches above the desired installation height and there just is not a simple way to lower the bed to the right position without major surgery on either the frame or the bedwood.
