## Installing a 54 GM bed on a 47-53 Frame: Some options, none easy

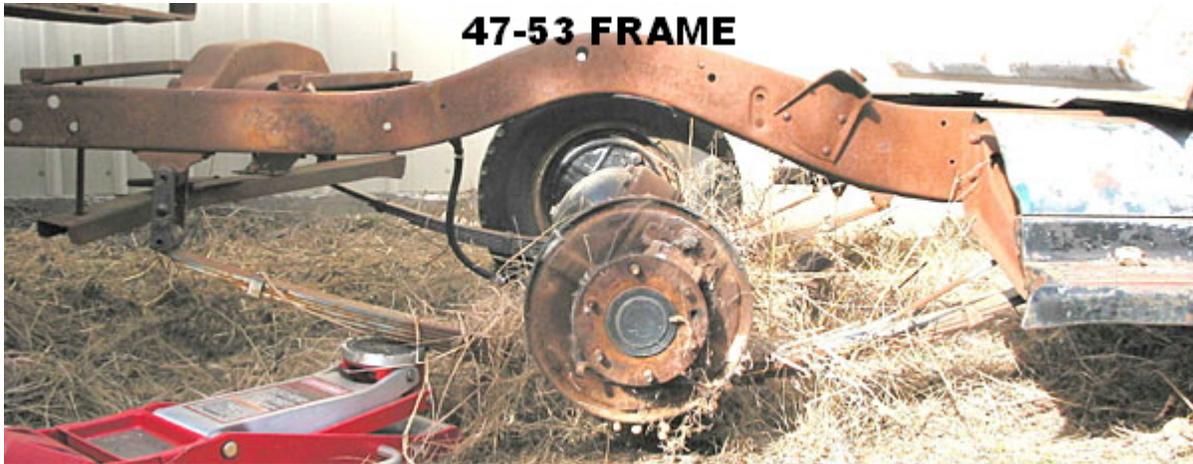
The main problem with installing a later bed on the 47-53 frame is the earlier frame has a much higher "kick up" or arch over the rear axle area. It is about 4 inches higher than the rest of the frame and the 54 frame "kick up" only rises about 2 inches. A 47-53 bed is installed on wooden blocks under the cross sills that raise the bed about 2-1/8 inches so the bottom of the wood is about 4 inches above the frame, which allows for the 4 inch kick up over the axle. The 54 bed does not use wood blocks under the cross sills so the bottom of the bed wood floor on a 54 truck is about 2-1/8 inches above the

frame. The photos show the two frames and the profile of the 54 frame is noticeably flatter than that of the 47-53 frame.
