Bed Side Interchangeability - GM Short Stepside Beds

We are frequently asked questions relating to fitting a bed or bed part from one year/model truck to a different year/model than that for which it was designed. Often the caller may have access to a used bed that is similar to one he needs and he wants to know if it will fit his truck. This tech information will address the interchangeability of GM short bed stepside pickup bed parts from 1954 through 1987. We will describe the significant features that changed as the designs changed over the years.

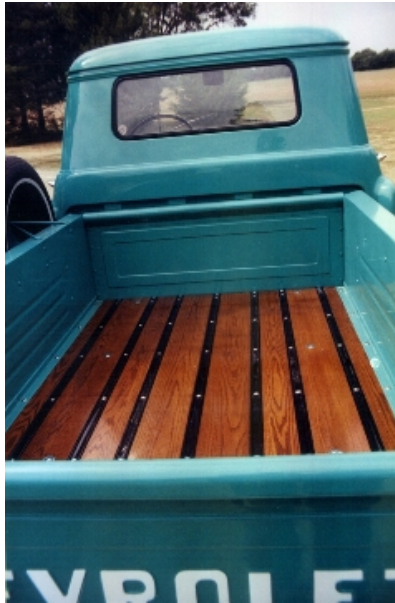
1955 (second series) - 1959 Short Bed

1. Bed side sheet metal is the same dimension as previous series, but the embossed pattern is changed to three ribs about 1" wide instead of the previous pattern following the shape of the fenders. This pattern of three ribs remained unchanged through the 1987 model.

2. The fender design changed to the more squared design that was unchanged from 1955 through 1966.
3. Rear sill mounting brackets are about 3" long and 2 1/8" tall, 31 3/4" apart.

4. There are three cross sills, and the third from the front is different than the other two. The third cross sill has its lower edges formed upward at the outer ends of the cross sill.

5. Seven bed strips and eight boards, the same dimensions as the 1954-1955 first series. The bed-to-frame hole locations however are changed, making the bed wood not interchangeable with the 1954-1955 first series.

6. Bed strips and angle strips have the same bolt pattern as 1954-1955 first series so they are interchangeable.
7. Chevrolet tailgate remained unchanged, The GMC tailgate logo is characterized by the large center 'M' which extends laterally under both the 'G' and the 'C'

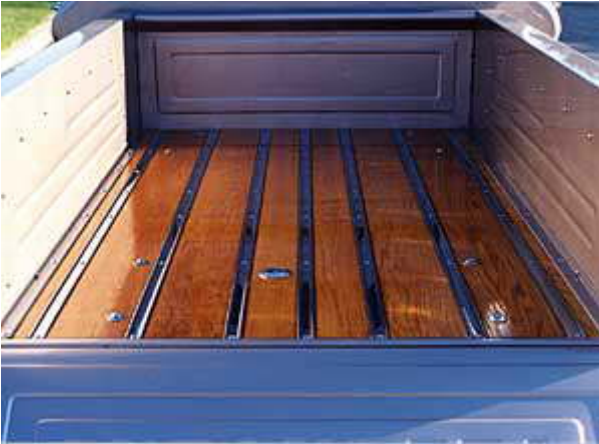
1963-1966 Short Bed

1. Bed side sheet metal is the same as the 55-59 and 62-66 but the 55-59 angle strip has a different bolt hole pattern. Therefore the bed sides of 1955 - 1959 may be interchanged with 1960-1966 if the angle strip is changed to the correct year series.

2. The fender design is unchanged from the 55-59 and 60-62 model.
3. Rear sill mounting brackets are about 4" long and 3" tall, 31 3/4" apart.
4. There are three cross sills and one reinforcing strip supporting the wood. The cross sills have a 1" tall spacer welded at each bed-to-frame bolt location. Because of this welded spacer, the cross sills should not be interchanged with any other year series due to the significant modifications required.

5. Seven bed strips and eight boards. The board length is unchanged from 60-62 models but the widths are different than 1955-1959 models. This affects bed strip bolt locations in rear sill, cross sills, reinforcing strip and front bed panel.

6. Bed strip and angle strip bolt locations are the same as 60-62 but different than 1955-1959 models, making them not interchangeable with 55-59.
7. Chevrolet tailgate remained unchanged. GMC tailgates changed to a block style lettering beginning in 1963.

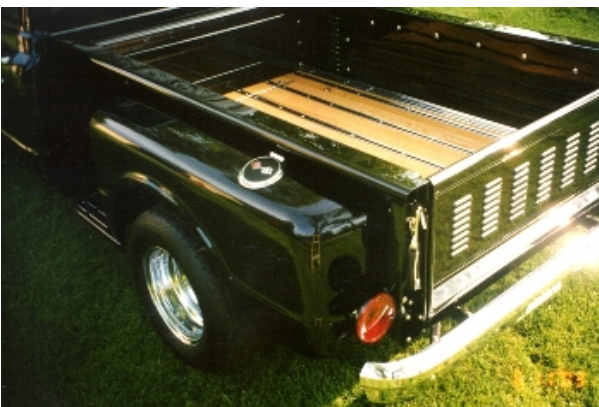
1967-1972 Short Bed

1. Bed side sheet metal is similar to previous years but the fender and step are changed as well as the angle strip bolt pattern. Other minor changes include the slightly larger bed side curl diameter and tail light mounting holes on the rear stake pockets.
2. The fender design changed for 1967 which changed the fender bolt pattern in the bed sides. 1968 and later fenders have side marker lights
3. The rear sill mounting brackets are about 4" long and 2 1/8" tall, 31 3/4" apart.

4. There are three cross sills and one reinforcing strip supporting the bed wood. The cross sills have a similar hole pattern as the 63-66 series but do not have the 1" spacer welded on the mounting hole locations. These cross sills could be used for the 63-66 application but would need to have the spacers welded to fit properly.
5. There are 7 bed strips and 8 boards. The bed wood boards have the same length and widths as the 63-66 series. The bed to frame bolt locations is different than the 63-66 trucks and the angle strip bolt pattern is also changed.
6. Bed strip and angle strip hole locations are different than the 63-66 series so these are not interchangeable.

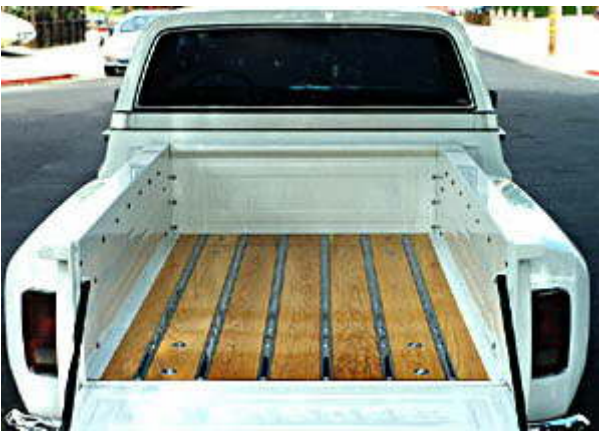
1973-1987 Short Bed

1. Bed side sheet metal is similar to previous years but the fender and step are changed as well as the angle strip bolt pattern. The bed side is shaped different than previous years in the area where the step attaches. Other minor changes include wiring loom holes in the bed sides below the wood in the rear area. Bed sides from this series will not work with previous years parts.
