Installation Instructions for 58-66 GM Wheel Tub Repair Flange

These instructions cover the repair of the wheel tub flange where it meets the wood floor in 1958 to 1966 GM trucks with the Fleetside bed. These areas are prone to rusting because of the wood holding moisture and the steel flange resting on the wood floor. This repair flange may be used to completely replace this flange or be used in pieces to repair this area. The wheel tub pictured at the left is an extreme case of deterioration caused by rust.

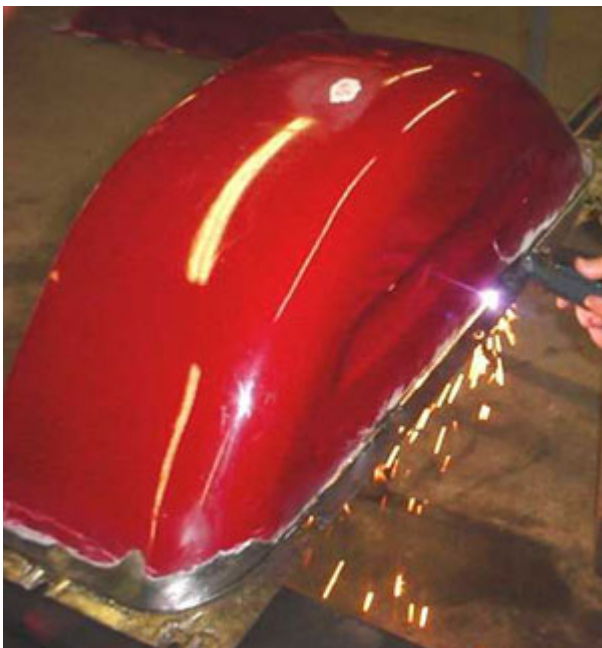
1. Lay the repair flange on top of the wheel tub flange. The bed strip humps on the repair flange go in the upward direction. Line up the square holes in the repair flange with the holes in the wheel tub flange. Clamp the repair flange in place. If your wheel tub flange has the holes rusted away, use the humps to position the repair flange.
2. Using the repair flange as a guide, mark or scribe the cut line around the wheel tub. You will want to keep the cut line on the flat portion of the wheel tub. Do not mark the wheel tub on the vertical wall. The repair flange will not be enough to cover this area and you do not want to change the height of the wheel tub.

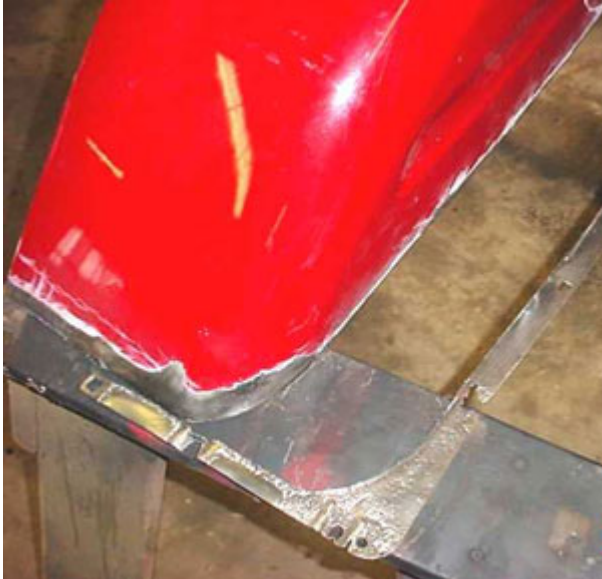
3. Remove the repair flange. Using a plasma cutter or a cut-off wheel, remove the damaged area of the wheel tub flange. Cut on the scrap side of the scribe line or marks made in the previous step. This wheel tub was rusted enough to need the complete flange replaced.

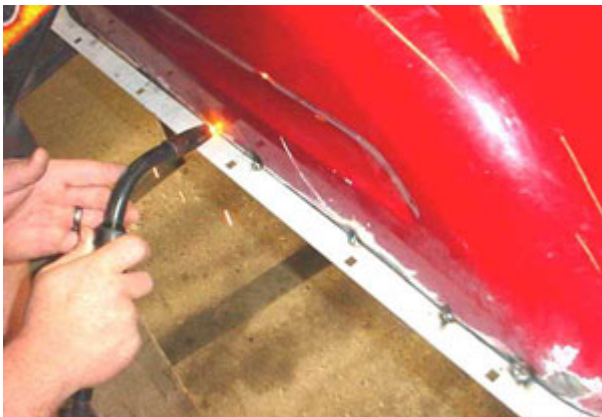
4. Fit the repair flange to the wheel tub. You may need to dress up the wheel tub where the damaged flange was removed. When the fit is good, tack weld the repair flange to the wheel tub in several places.

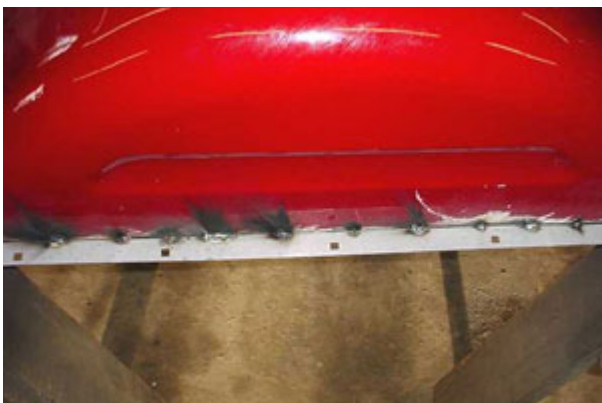
5. Continue welding the repair flange to the wheel tub. Use small welds and move around the wheel tub so that the repair flange does not warp from weld heat. If you are repairing both wheel tub flanges, alternate between them to allow the welds to cool.

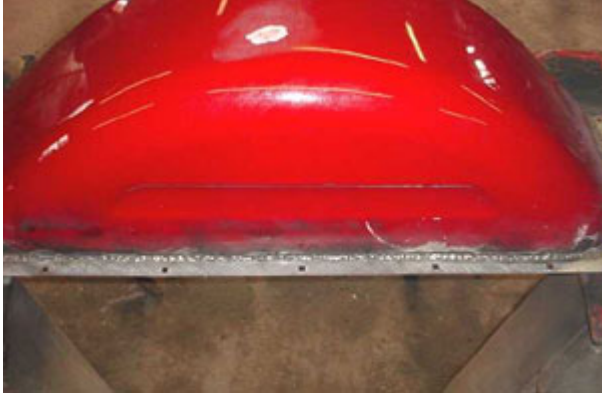
6. Weld between the other welds until the entire seam is welded. Remember to allow the welds to cool so that warping does not occur. Check on the underside of the wheel tub for proper penetration of the welds.

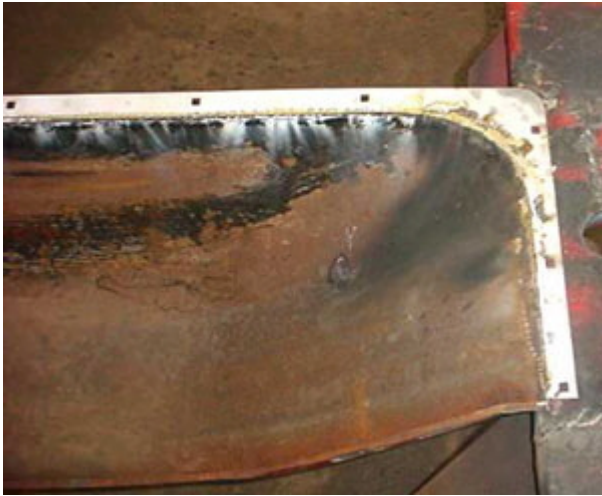
7. Grind the welds smooth on both top and the underside of the wheel tub. Work slowly and avoid building up too much heat. Be extra careful around the hump areas where the bed strips go. A grinder could easily damage this area.
