## Bed Side Interchangeability - GM Short Stepside Beds

We are frequently asked questions relating to fitting a bed or bed part from one year/model truck to a different year/model than that for which it was designed. Often the caller may have access to a used bed that is similar to one he needs and he wants to know if it will fit his truck. This tech information will address the interchangeability of GM short bed stepside pickup bed parts from 1954 through 1987. We will describe the significant features that changed as the designs changed over the years.

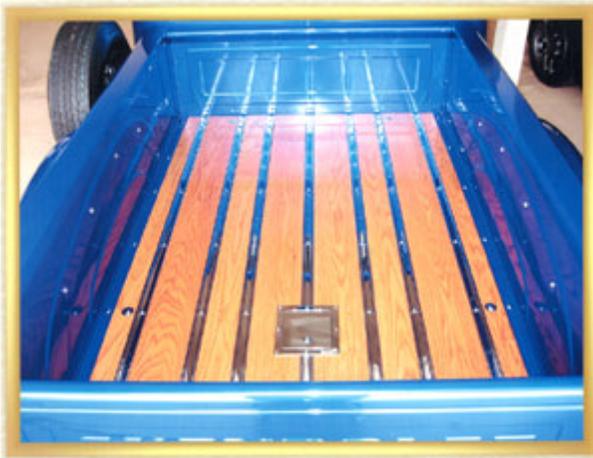
### 1954 - 1955 (first series) Short Bed

1. An embossed pattern stamped in the bed side sheet metal follows the shape of the fender outline where the fender attaches to the bed sides.
2. Fenders have a rounded shape and are the same as those used in the 47-53 model years.
3. Rear sill mounting brackets are about 4" long and 2 1/8" tall, 44 1/4" apart.
4. There are three cross sills and they are about 2 1/8" tall, a little taller than previous years. Also, beginning with the 54 year GM no longer used the wooden bed-to-frame bed mounting blocks.
5. Seven bed strips and eight boards, the same board widths as previous 51-53 model GM beds. Board length and bed strip length is 77 1/8", slightly longer than previous models.
6. GMC and Chevrolet both had new design tailgates for this year. Tailgate is embossed with large rectangular pattern similar to the front bed panel and "Chevrolet" or GMC is embossed in the center area.

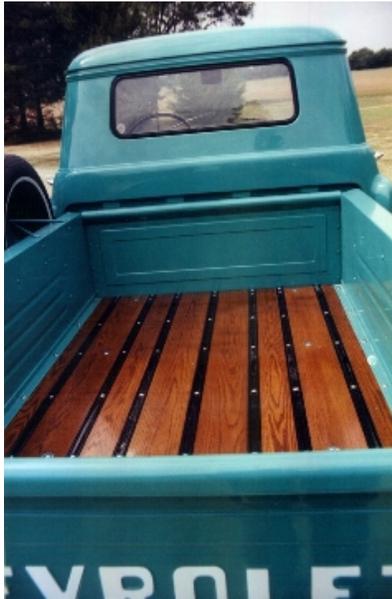
### 1955 (second series) - 1959 Short Bed

1. Bed side sheet metal is the same dimension as previous series, but the embossed pattern is changed to three ribs about 1" wide instead of the previous pattern following the shape of the fenders. This pattern of three ribs remained unchanged through the 1987 model.

2. The fender design changed to the more squared design that was unchanged from 1955 through 1966.
3. Rear sill mounting brackets are about 3" long and 2 1/8" tall, 31 3/4" apart.

4. There are three cross sills, and the third from the front is different than the other two. The third cross sill has its lower edges formed upward at the outer ends of the cross sill.

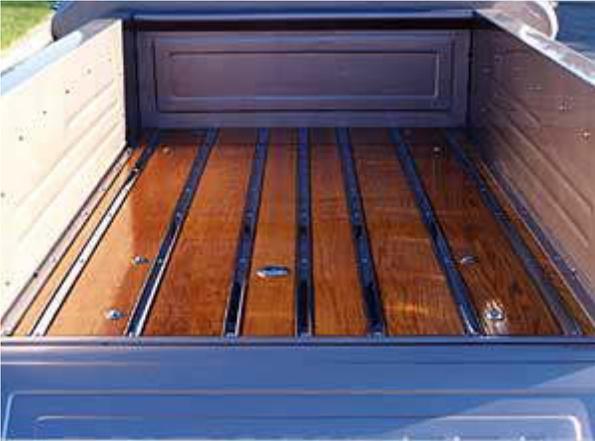
#### 1963-1966 Short Bed

1. Bed side sheet metal is the same as the 55-59 and 62-66 but the 55-59 angle strip has a different bolt hole pattern. Therefore the bed sides of 1955 - 1959 may be interchanged with 1960-1966 if the angle strip is changed to the correct year series.

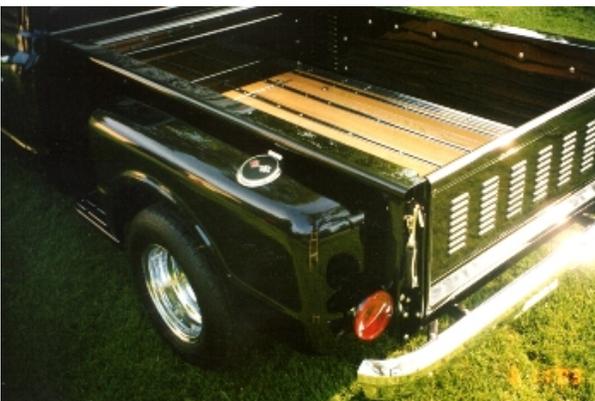
#### 1967-1972 Short Bed

1. Bed side sheet metal is similar to previous years but the fender and step are changed as well as the angle strip bolt pattern. Other minor changes include the slightly larger bed side curl diameter and tail light mounting holes on the rear stake pockets.
2. The fender design changed for 1967 which changed the fender bolt pattern in the bed sides. 1968 and later fenders have side marker lights
3. The rear sill mounting brackets are about 4" long and 2 1/8" tall, 31 3/4" apart.

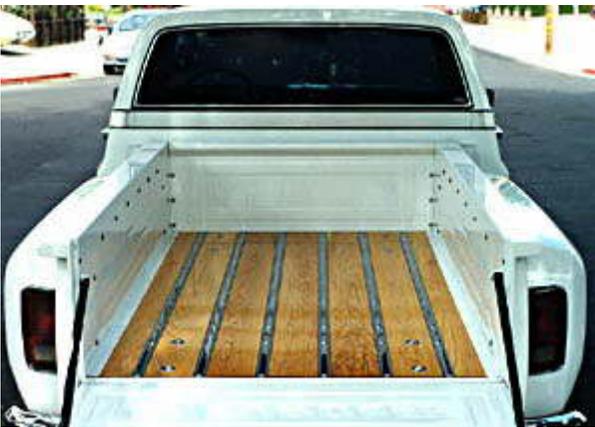
### **1973-1987 Short Bed**

1. Bed side sheet metal is similar to previous years but the fender and step are changed as well as the angle strip bolt pattern. The bed side is shaped different than previous years in the area where the step attaches. Other minor changes include wiring loom holes in the bed sides below the wood in the rear area. Bed sides from this series will not work with previous years parts.
