## Installation Instructions for 58-66 GM Wheel Tub Repair Flange

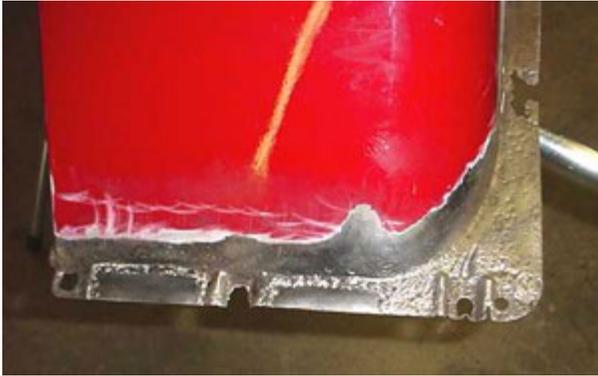
These instructions cover the repair of the wheel tub flange where it meets the wood floor in 1958 to 1966 GM trucks with the Fleetside bed. These areas are prone to rusting because of the wood holding moisture and the steel flange resting on the wood floor. This repair flange may be used to completely replace this flange or be used in pieces to repair this area. The wheel tub pictured at the left is an extreme case of deterioration caused by rust.

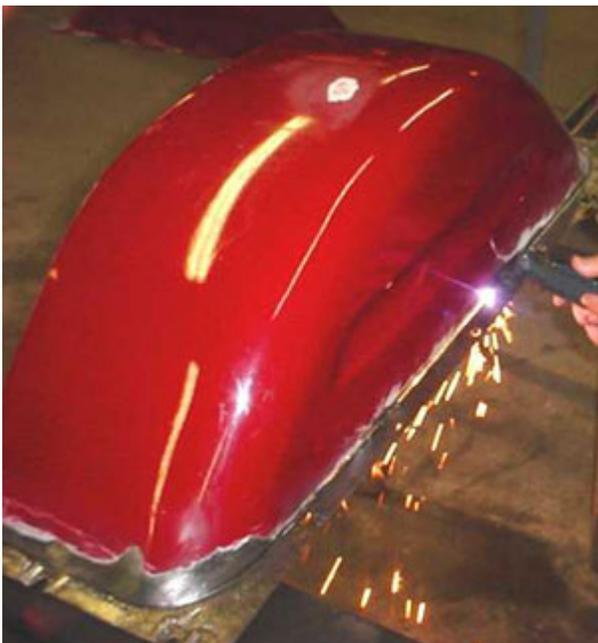
1. Lay the repair flange on top of the wheel tub flange. The bed strip humps on the repair flange go in the upward direction. Line up the square holes in the repair flange with the holes in the wheel tub flange. Clamp the repair flange in place. If your wheel tub flange has the holes rusted away, use the humps to position the repair flange.
2. Using the repair flange as a guide, mark or scribe the cut line around the wheel tub. You will want to keep the cut line on the flat portion of the wheel tub. Do not mark the wheel tub on the vertical wall. The repair flange will not be enough to cover this area and you do not want to change the height of the wheel tub.

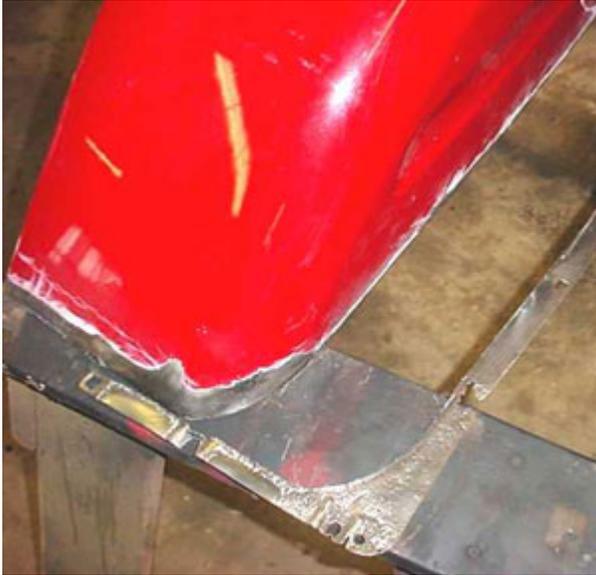
3. Remove the repair flange. Using a plasma cutter or a cut-off wheel, remove the damaged area of the wheel tub flange. Cut on the scrap side of the scribe line or marks made in the previous step. This wheel tub was rusted enough to need the complete flange replaced.

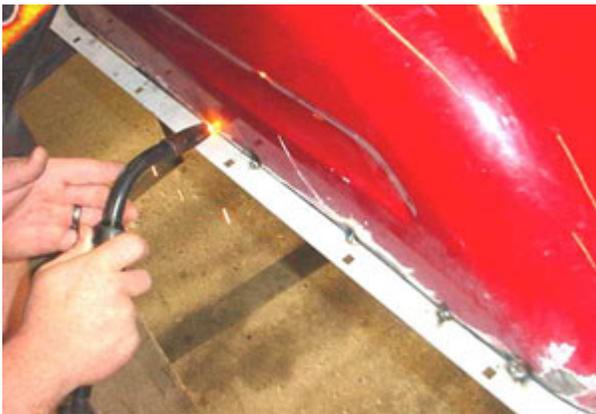
4. Fit the repair flange to the wheel tub. You may need to dress up the wheel tub where the damaged flange was removed. When the fit is good, tack weld the repair flange to the wheel tub in several places.

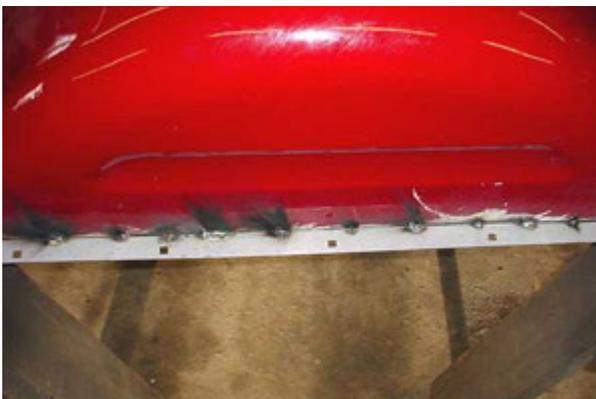
5. Continue welding the repair flange to the wheel tub. Use small welds and move around the wheel tub so that the repair flange does not warp from weld heat. If you are repairing both wheel tub flanges, alternate between them to allow the welds to cool.

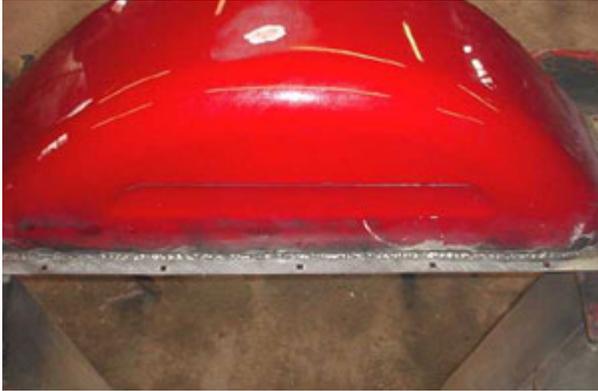
6. Weld between the other welds until the entire seam is welded. Remember to allow the welds to cool so that warping does not occur. Check on the underside of the wheel tub for proper penetration of the welds.

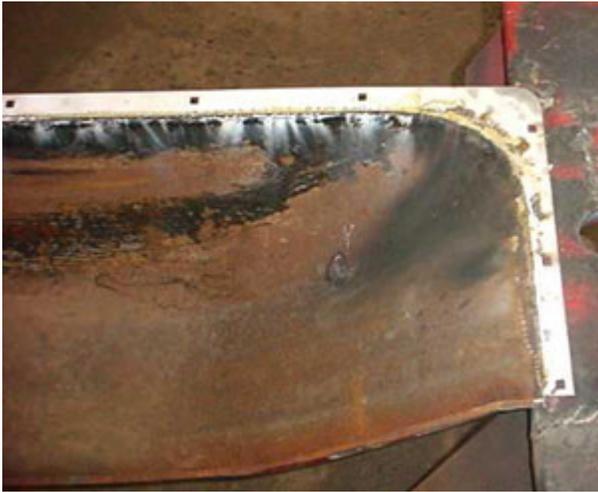
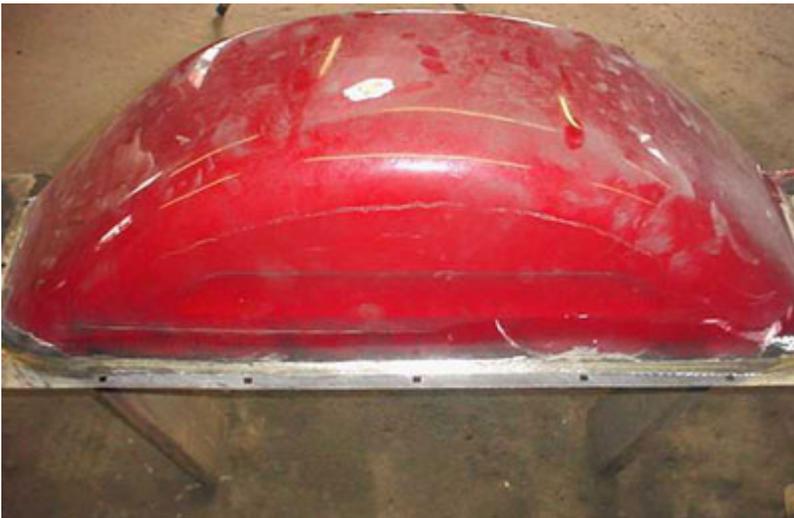
7. Grind the welds smooth on both top and the underside of the wheel tub. Work slowly and avoid building up too much heat. Be extra careful around the hump areas where the bed strips go. A grinder could easily damage this area.

The repair flange should now be an integral part of the wheel tub. Sand these areas; primer and paint as desired.
