BED SIDE INNER REPAIR PANELS

58-66 WHEELHOUSE REPAIR FLANGE

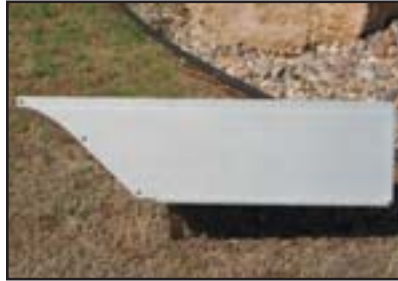
- Available for short bed (shown) and long bed Fleetside trucks.
- These go in front of and behind the wheel well to repair the rusted or damaged inner wall of the fleetside bed sides.
- Holes are punched for attachment to the wheel tubs and the wood bed.
- The top is embossed with an offset for ease of welding and placement of panels.
- These panels are made of 16-gage electro-galvanized steel.
- *Made by MAR-K in Oklahoma City, USA.*
- Includes complete instructions.

Tech Tip for Inner Repair Panels: These replacement panels extend from the front bed panel to the wheelhouse opening and from the rear stake pocket to the wheelhouse opening. They will replace the sheet metal from the lower flange with holes to the top of the wheelhouse opening on the bed side. Experienced installers may choose not to use the entire replacement panel if it is not needed, but the instructions show the entire panel being used. We strongly advise you to read the instructions thoroughly and understand that cutting and welding are involved before proceeding. It will be necessary to disassemble the box and remove the wheelhouse from each bed side. Instructions are included with the parts or are also online at www.mar-k.com.

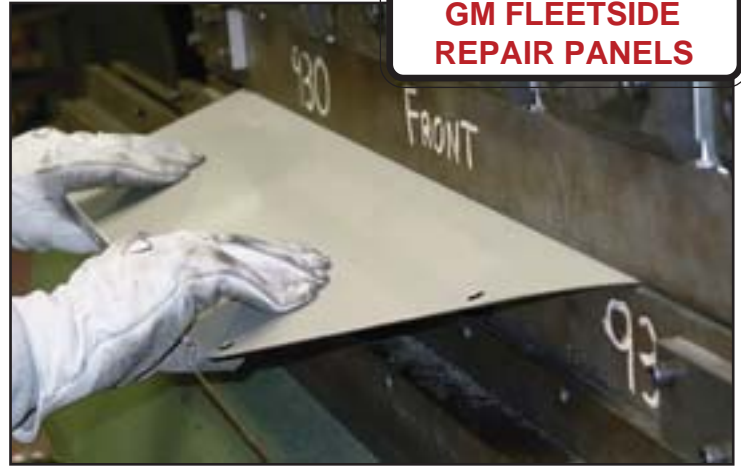
The top of MAR-K's Fleetside Repair Panels is embossed with an offset using this CNC press brake.

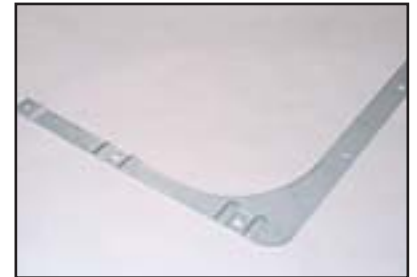
- This flange for 58-59 GM Fleetside and 60-66 GM Fleetside trucks is used to repair the rusted or damaged area of the wheel tub where it meets the wood floor.
- 16-gage electro-galvanized steel flange has bed strip embossment like original. Instructions included.
- Requires 2 flanges per truck.
- *Made by MAR-K in Oklahoma City, USA.*

Tech Tip for Wheelhouse Repair Flange: This part is to repair the wheel tub flange where it meets the wood floor. These areas are prone to rusting because of the wood holding moisture and the steel flange resting on the wood floor. This repair flange may be used to completely replace this flange or be used in pieces to repair this area.
